**KALAMAZOO RIVER**

# CHIPYARD OIL INVESTIGATIONS

RE: Otsego Paperboard plant Hydraulic Oil Spill -  
HYDROGEOLOGIC ANALYSIS REPORT

The objective of this study was to investigate possible soil and groundwater contamination by hydraulic oil. The site is located on the north side of the Paperboard Plant and under the chip conveyor in the wood yard. Specifically, this study included the performance of soil borings, installation of monitoring wells, soil and groundwater sampling and analysis, conceptual development of remedial actions, and preparation of an engineering report.

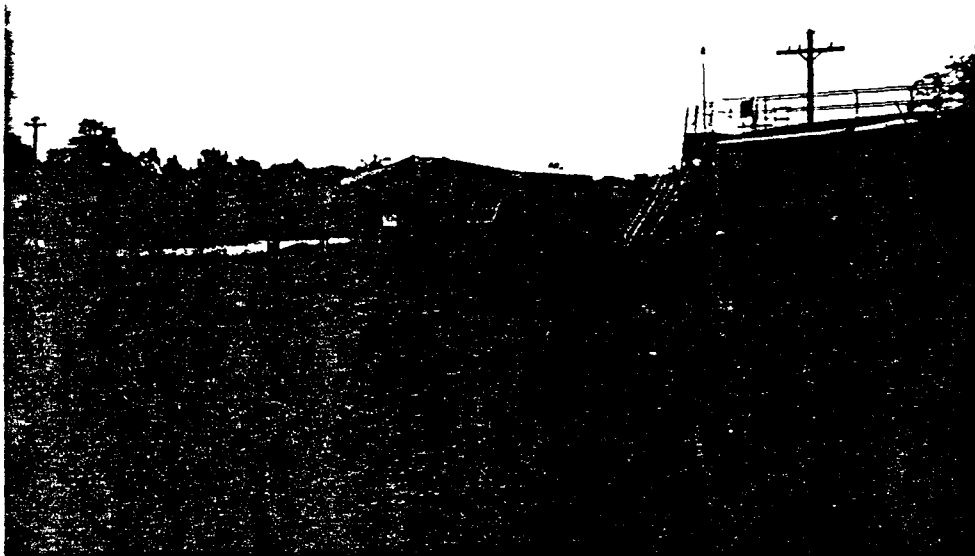
DESCRIPTION: This photograph shows a clarifier, weir house and  
a settling pond.DATE: 6/27/90TIME: 1413DIRECTION OF  
PHOTOGRAPH:EastWEATHER  
CONDITIONS:Sunny, PartlyCloudy ~ 69°F

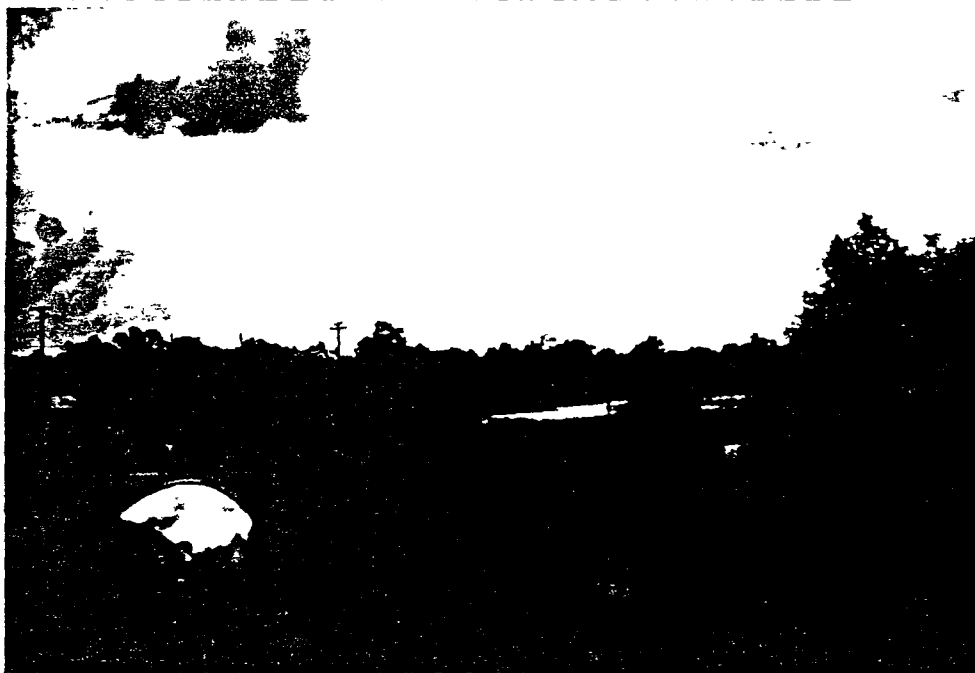
DESCRIPTION: This photograph shows a settling pond and empty  
drums.

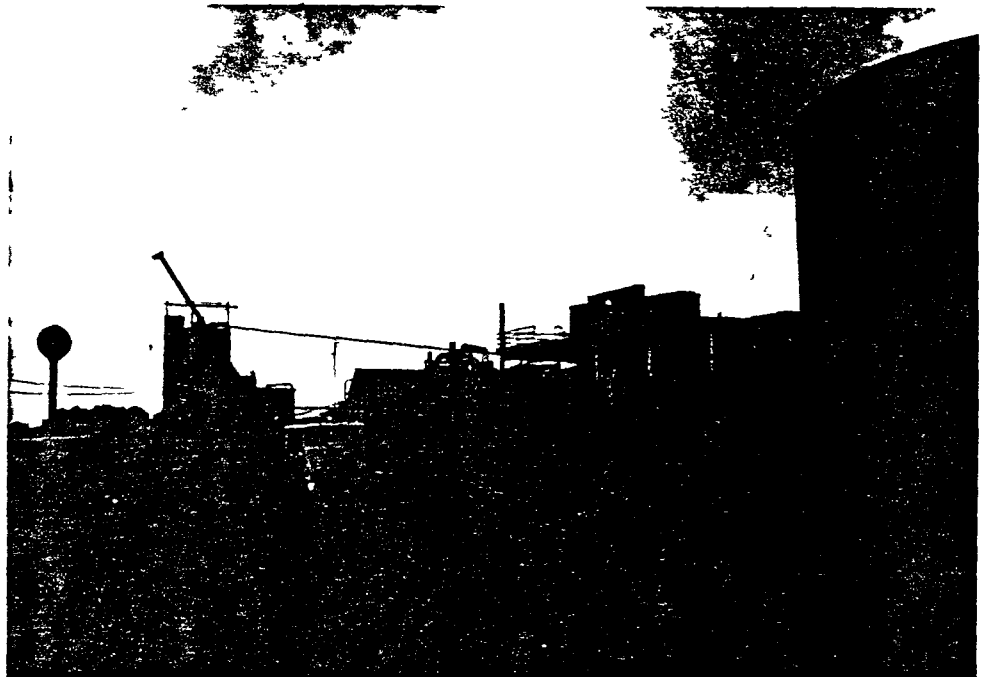
DESCRIPTION: This photograph shows the south side of the Main Plant building and the area of a spent liquor storage pond

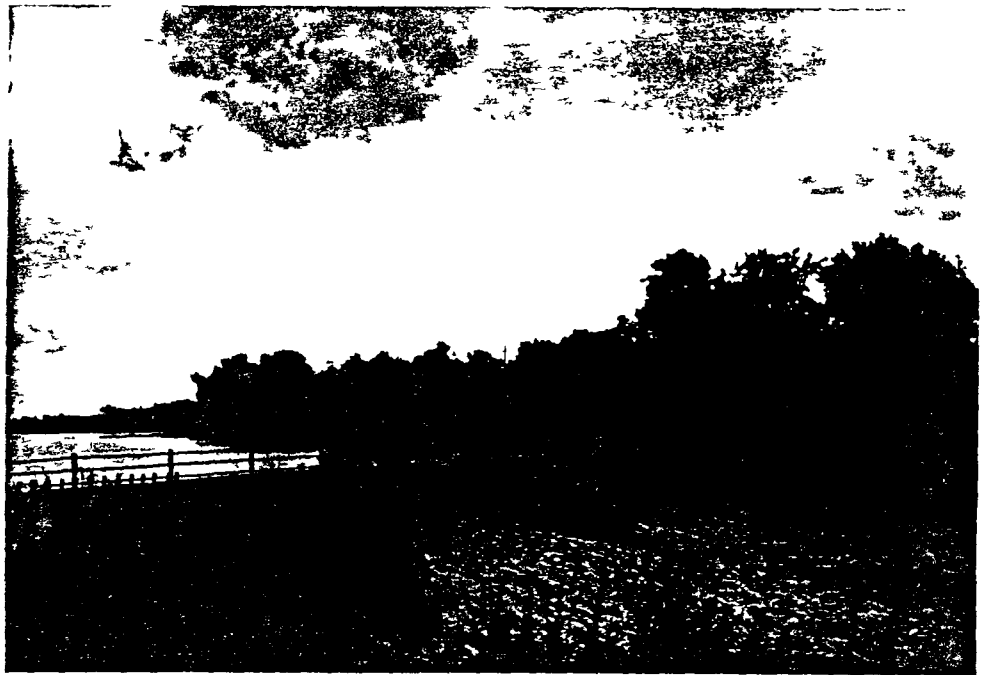
DESCRIPTION: This photograph shows the dam.
